LP-DC212
LP-DC234

LASER PLUS 4 BAND BLOCK DOWNCONVERTER SYSTEM

INSTRUCTION MANUAL

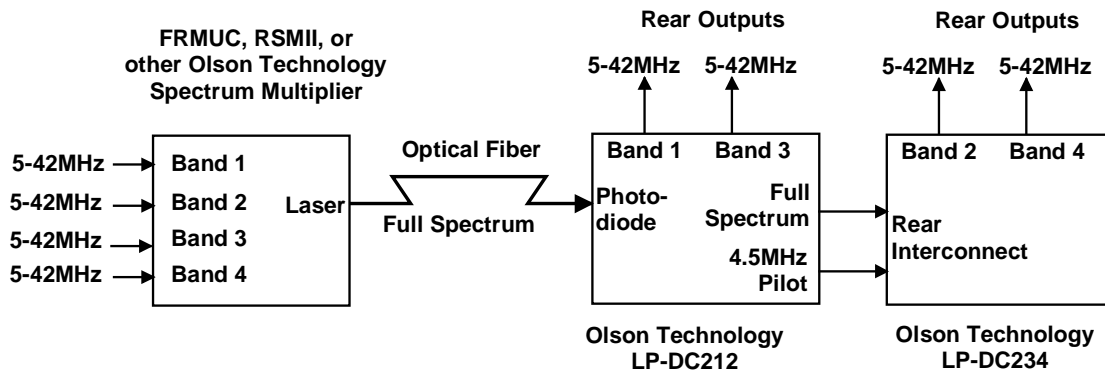
System Overview

The LP-DC212 and LP-DC234 are the receive sections of a return spectrum multiplier system. They can double or quadruple the bandwidth of any optical return link. The LP-DC212 by itself can function as a bandwidth doubler. Both units together will quadruple the return bandwidth. The LP-DC234 requires an LP-DC212 in order to function. All outputs are phase locked to their inputs, providing transparent operation.

The units plug into an Olson Technology high density Laser Plus chassis. Each unit occupies one slot. The following diagram shows the overall system.

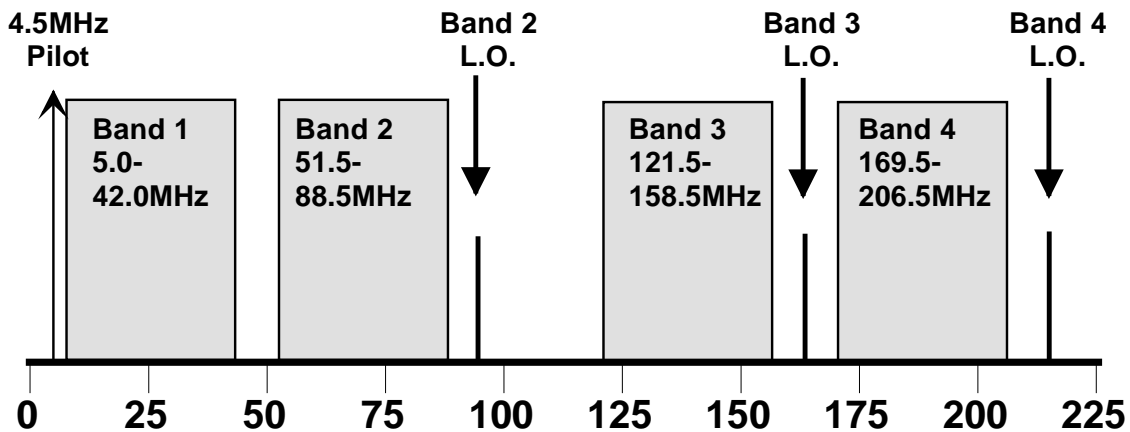
Return Path Spectrum

The next diagram shows the full RF spectrum as it is at both ends of the optical link. Some local oscillator presence is normal. It will not cause in-band distortion products or degrade NPR.

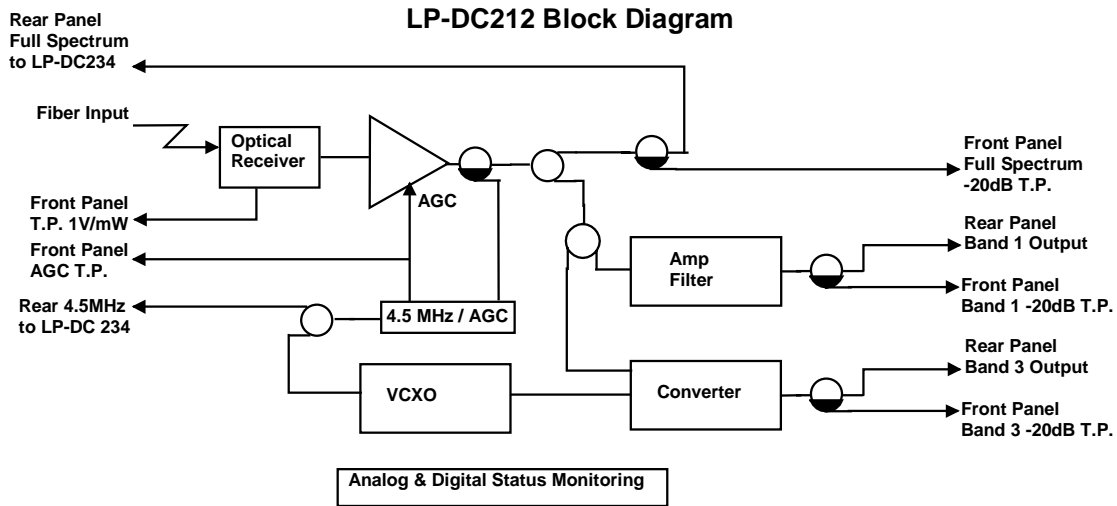
The next picture is a block diagram of the LP-DC212. This unit contains the optical receiver and the band 3 converter. It also contains the 4.5MHz pilot extraction circuitry, which is used for AGC and phase lock. It supplies the pilot and the full RF input spectrum to the LP-DC234.

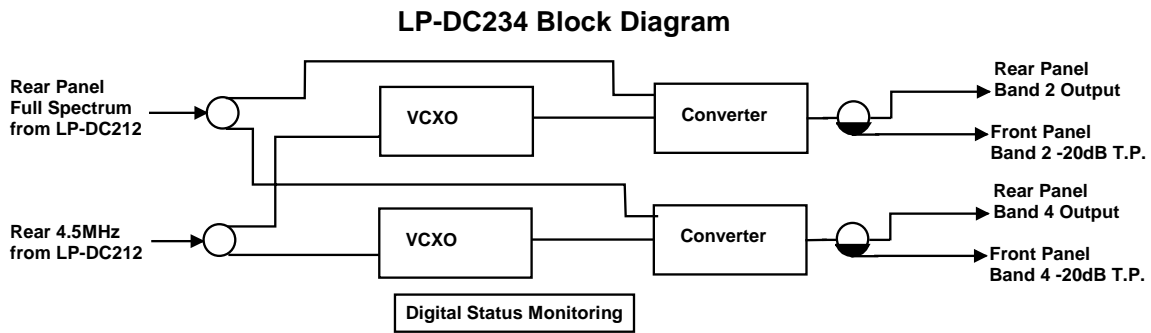
The next picture is a block diagram of the LP-DC234. This unit contains the band 2 and band 4 converters. This unit does not have an optical receiver and is not a self-contained unit. It must be connected to a LP-DC212 to function.

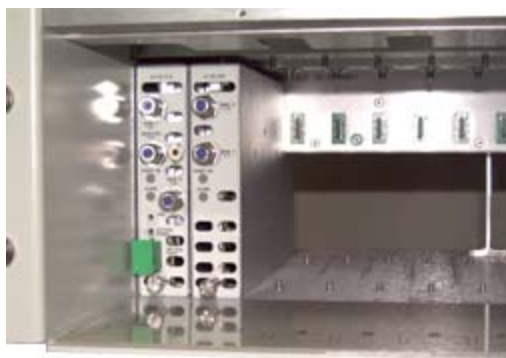
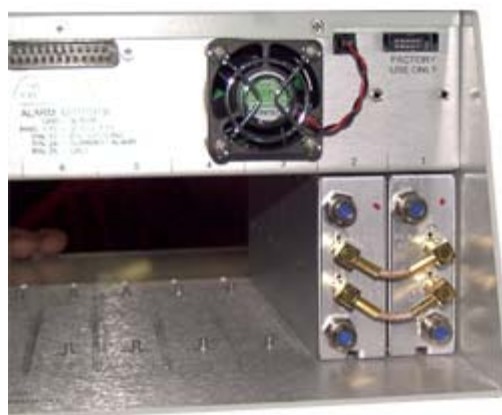
The Laser Plus main chassis should be rack mounted before the modules are installed. This chassis should **never** be used as a shipping container. The modules should be gently slid into the chassis. To avoid damage to the interconnect cables, install the LP-DC's from the right to the left, as shown below. The LP-DC212 should always be to the left of the LP-DC234 in which it is connected to. Connect the rear SMB cables.

Note that while the main chassis slots are numbered from the left on the front, they are numbered from the **right** on the rear. This could cause confusion relating to which LP-DC212 is connected to which LP-DC234.

The primary problems at turn on are poor optical connections due to contamination and reversed or incorrectly connected cables. Confusion between the main chassis slot numbering convention from front to rear is not uncommon.

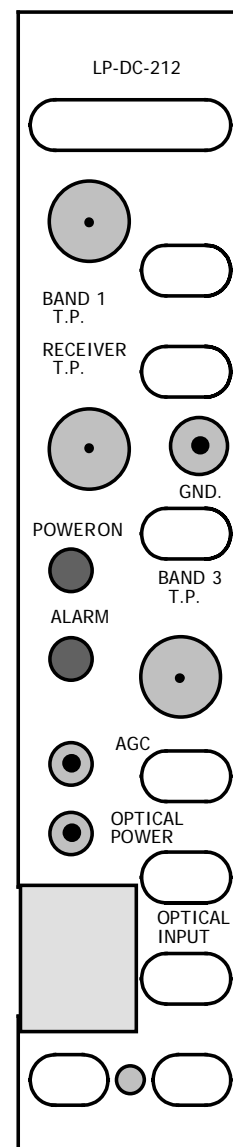
LP-DC212

The standard optical input connector is type SC/APC.

There are 3 front panel –20dB RF test points. The receiver T.P. depicts the full spectrum RF output from the optical receiver. The other 2 test points reflect the rear panel sub-band outputs. Typical 4.5MHz pilot levels are +14dBmV at the RX T.P. and +10dBmV at the band 1 T.P. There is no pilot at the band 3 T.P.

The power LED should always be on and green. The alarm LED is always on. It is green unless a failure occurs. It monitors optical input levels, RF AGC, and VCXO unlock.

The DC test points should be used with a high impedance meter. The optical input T.P. is calibrated for 1V/mW @ 1310 nm. A correction factor must be applied for other wavelengths.

The AGC test point reflects the strength of the 4.5MHz pilot signal. A higher voltage indicates less signal.

The rear panel has the 2 RF F output connectors and the 2 SMB connectors that connect to the LP-DC234. Typical pilot levels are +50dBmV at the pilot connector and +32dBmV at the RF connector.

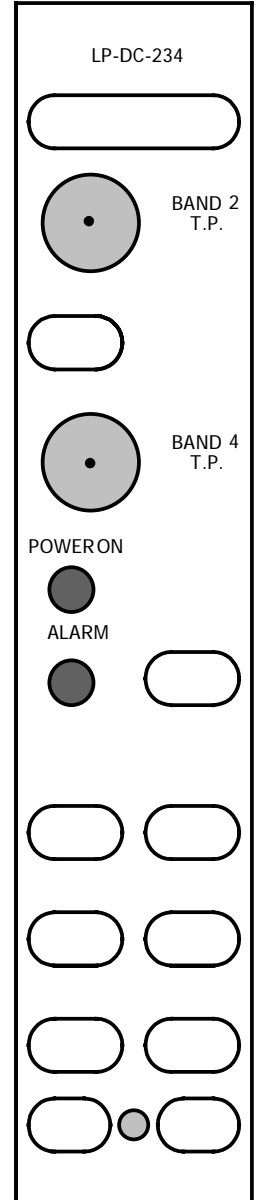
LP-DC234

There are 2 front panel -20dB RF test points. For level setting, the accuracy of these band 2 and band 4 test points is ± 1 dB. No 4.5 MHz pilot is present at these test points.

The power LED should always be on and green. The alarm LED is always on. It is green unless a failure occurs. It monitors VCXO unlock.

The rear panel has the 2 RF F output connectors and the 2 SMB connectors that connect to the LP-DC212.
